**Professional Analysis
and Consulting, Inc.**

Project No. 2017

Brittany B. Hilton

SIG SAUER, Inc.

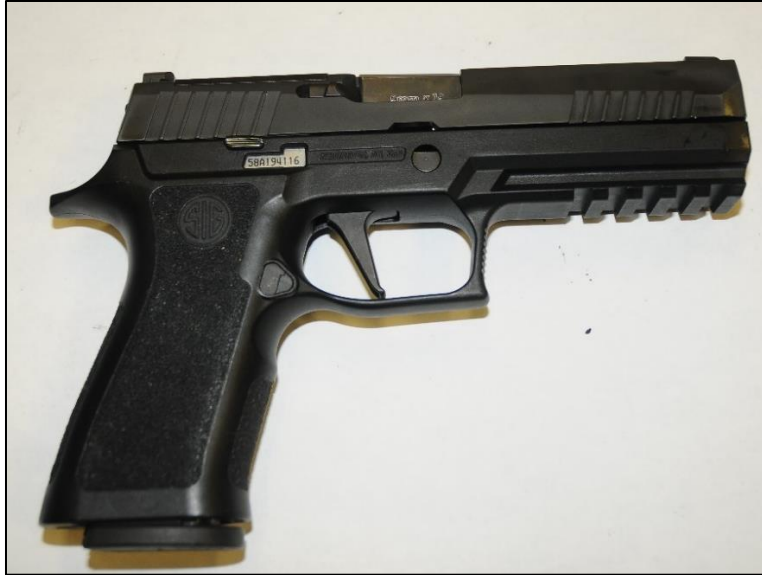
During the July 14, 2022, inspection, the subject P320 X Carry 9mm was verified as having Serial No. 58A194116. This was an upgraded version of the P320 and was otherwise in as-produced condition, except for normal and anticipated wear since Detective Hilton utilized the subject firearm as her service weapon. Detective Hilton had significant qualification and training practice firing the weapon and was familiar with its operation and exercising proper firearm safety. As mentioned, Sig Sauer took possession and disassembled the subject firearm prior to the July 2022 inspection and prepared an inspection report.⁵

Figure 1 - Subject Sig Sauer P320 X Carry 9mm

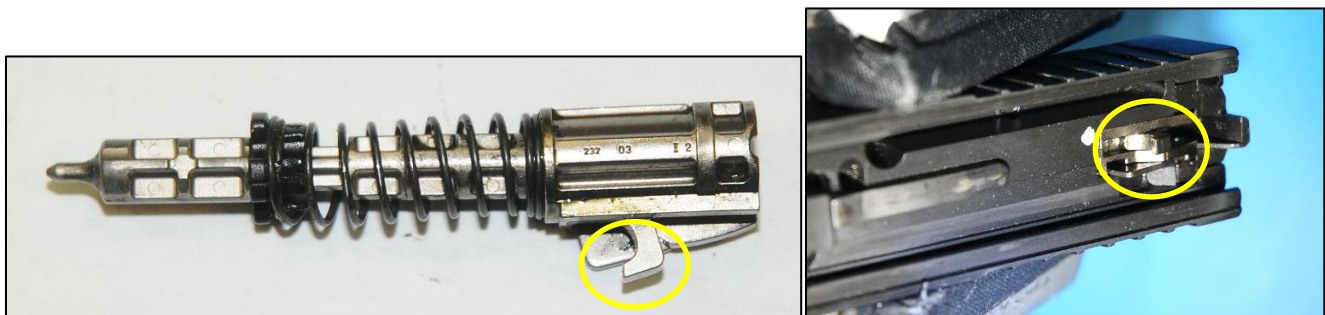
1. The sear and striker pin components, the engagement of which is a critical feature of this design, are produced using a Metal Injection Molding (MIM) process and do not have any secondary machining performed on the small engagement surfaces. MIM produced components can have areas of uncontrolled variability due to the manufacturing process. For surfaces where tight tolerances and consistent fit-up are required, MIM parts will typically have secondary processing, or machining, to eliminate the variation. See Figures 2 – 3.

Figure 2 - Striker assembly with striker foot circled (left), striker assembly in the slide assembly (right)

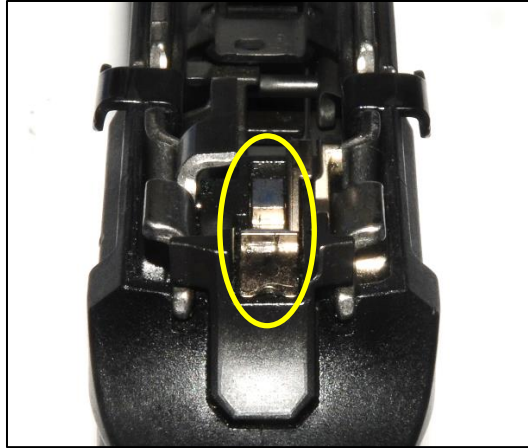
Figure 3 – Top rear view of sear (circled) and off-center striker drag marks

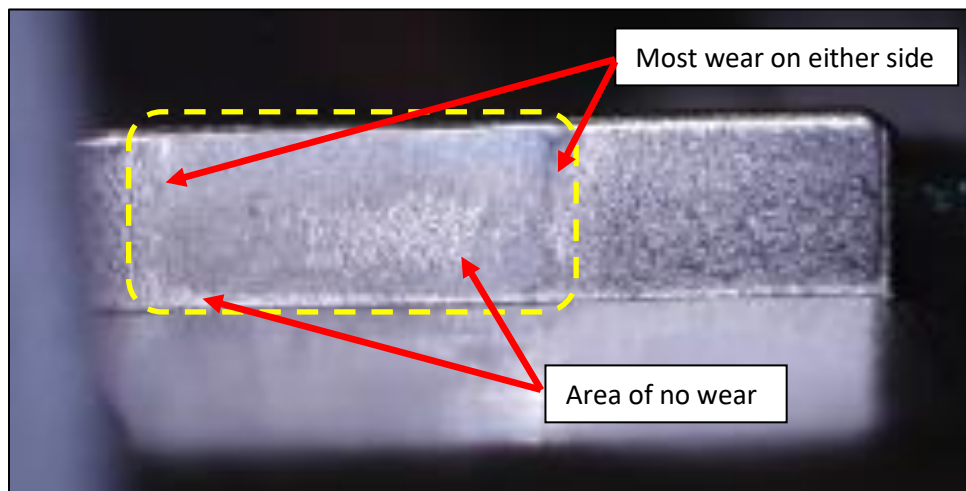
2. The sear and striker foot portion of the striker pin both exhibited inconsistencies on the surfaces that are in contact with each other, minimizing the actual contact surface area that is needed to keep the parts engaged until the trigger is pulled. In addition to the MIM as manufactured surfaces (rough and unmachined), both parts also exhibited a raised area around the periphery of the interface surface. This has been referred to by others as rollover and appears to be a combination of flashing, radiused corners, and shrinkage of the inner surface area. The end result is reduced contact surface area between both components, making the firearm more susceptible to un-commanded discharge. Figure 4 is a close up of the sear step with clear wear marks from the striker foot that shows an inconsistent pattern, including an area within the step with no wear. There is also an inconsistent surface along the top edge of the sear step. Figure 5 has zoomed in photographs of the subject striker foot showing the raised area around the periphery of the face, radiused edges, and an unmachined surface.

Figure 4 - Subject sear step with striker foot marks (outlined in dashed yellow)

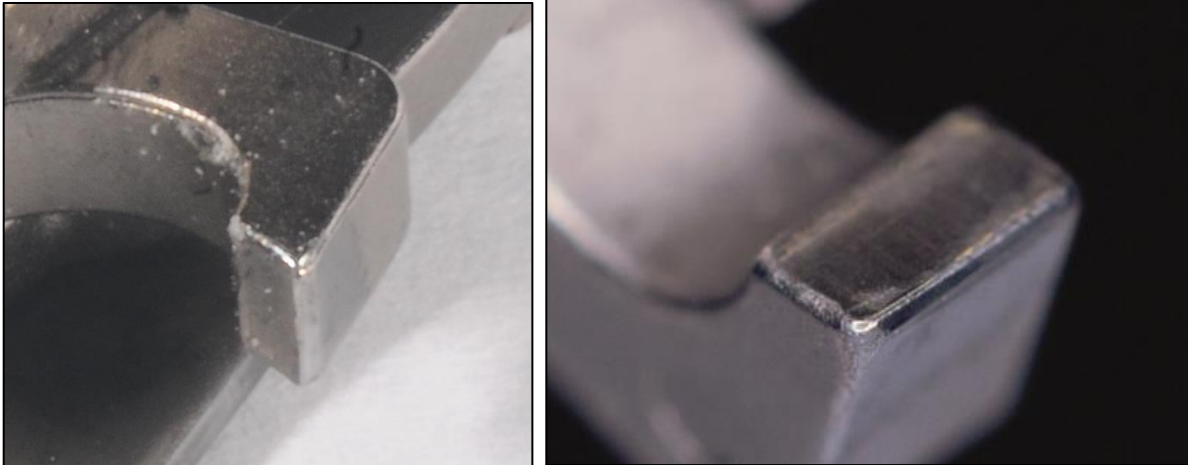
Figure 5 – Subject striker foot showing raised outline and unmachined surface

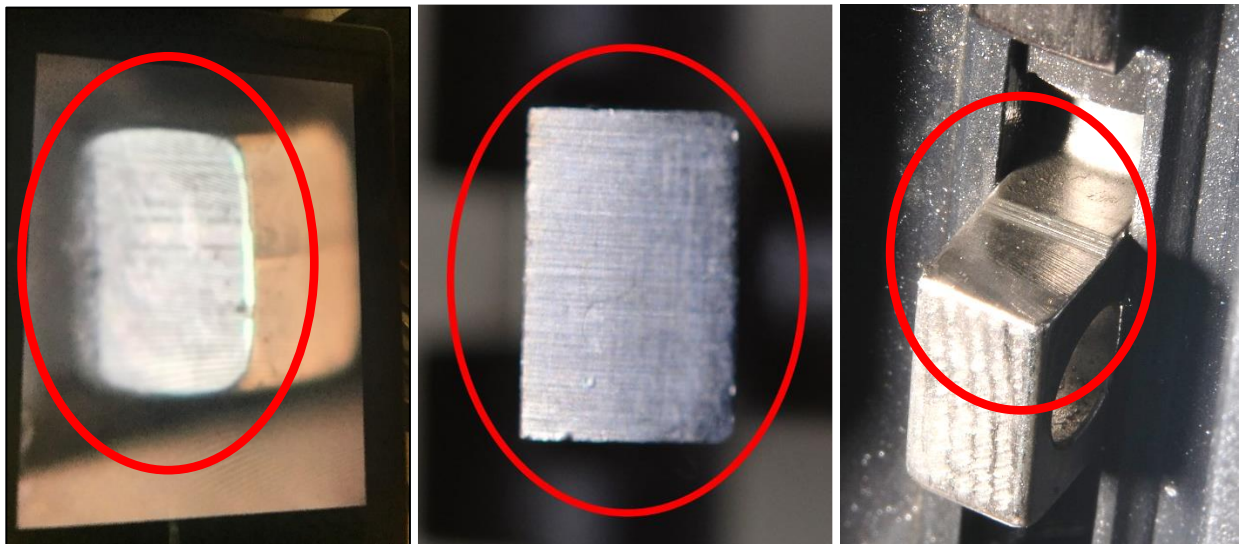
3. In comparison, the photos in Figure 6 show the machined (or some other secondary processing after molding) surface of the striker foot and sear from other manufacturers firearms. As mentioned, the CT scan is unable to be utilized in quantifying or measuring the inconsistencies of the surfaces of the striker foot or the sear step due to its resolution. Feature size and dimensions, including radiused corners, can be measured from CT scan, described more below.

Figure 6 - Other firearms - striker foot (left), and sear face (center), and striker foot (right), all with machined flat surfaces

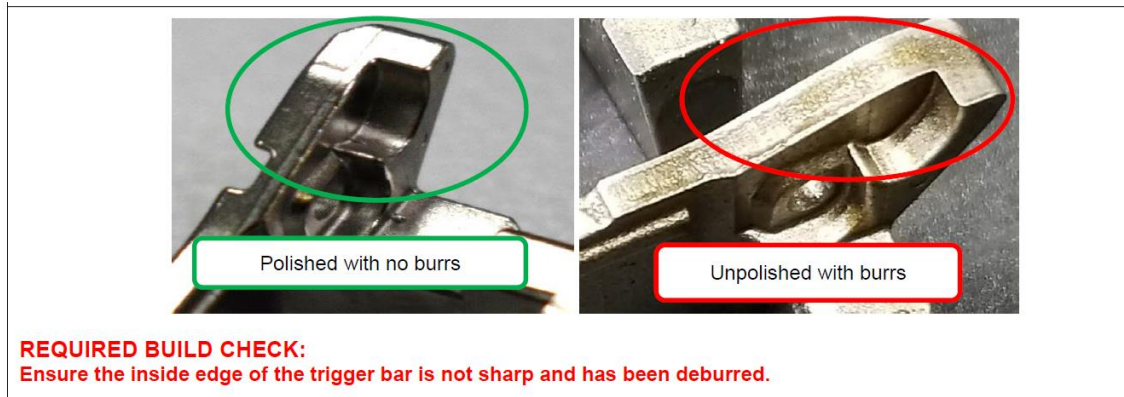
Additionally, the Sig Sauer Quality Control Document⁶ specifies that the trigger bar needs to be “*polished with no burrs*” but does not specify the same requirement for the sear or the striker pin. Sig Sauer recognizes the need to perform secondary processing on some parts of the P320 but choose to not do so on the sear or the striker pin. See Figure 7.

Figure 7 - Image from Sig Sauer P320 Assembly and Quality Inspection Master

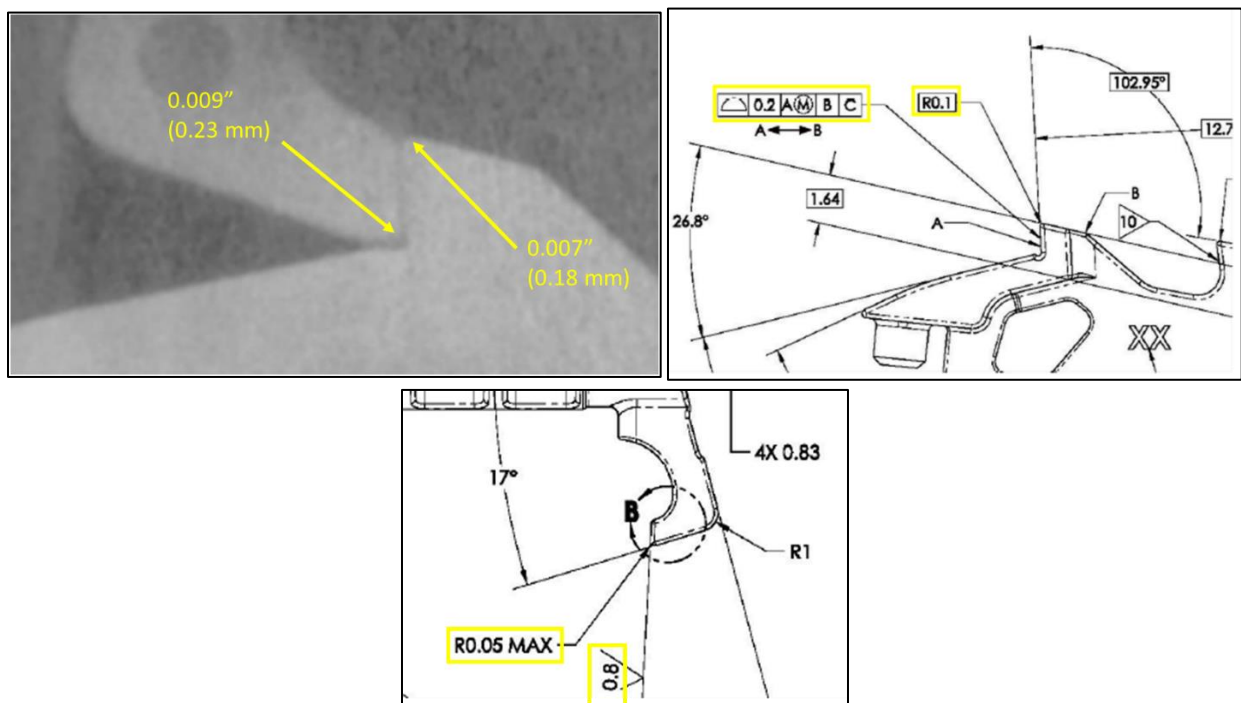
4. A CT scan was also used to document the striker and sear engagement areas as compared to the drawings, shown in Figure 8. The sear step had the top surface, where the striker foot is released from, measured radius at 0.007" (0.18 mm), with the Sig Sauer drawing #1302192⁷ indicating a radius of 0.1 mm. The surface profile where the striker engages indicates a tolerance of 0.2 mm, but as with the other components discussed in this report, this dimension could not be quantified with the CT scan. The CT scan of the bottom edge of the striker foot radius measured at 0.009" (0.23 mm). The Sig Sauer striker drawing #1302193⁸ indicates that the radius on the bottom edge of the striker foot at 0.003" (0.1 mm). This drawing also indicates that the surface that engages with the sear step has a surface finish specification of 0.8, but this could not be quantified with the CT scan.

Figure 8 - CT scan of the subject striker and sear (left), sear drawing (right), and striker drawing (bottom)

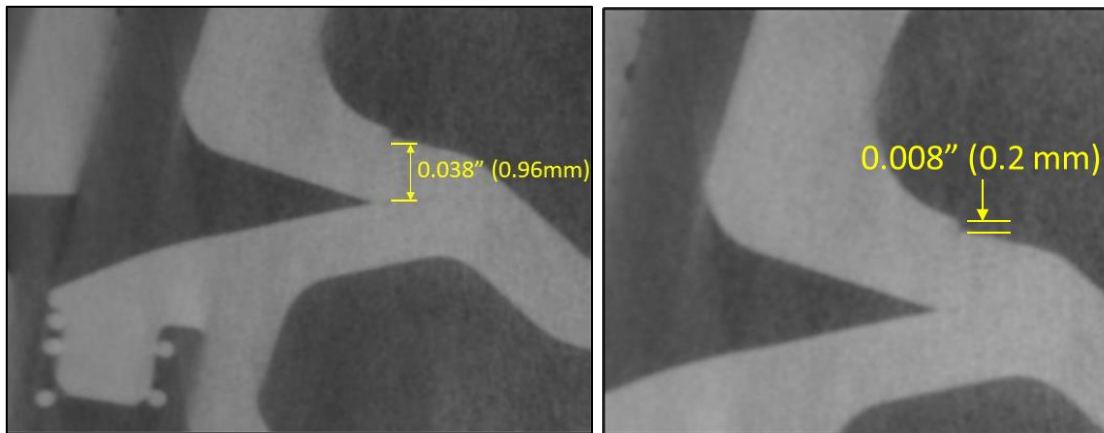
5. In addition to the lack of secondary processing on the sear and striker foot, there is also a vertical misalignment of the two parts, as shown in the CT scan shown in Figure 9. The striker foot is unable to fully engage with the sear face surface, reducing the area available for the engagement of the two parts. With the minimal amount of overlap and engagement between the two components, a minor amount of vibration or relative movement between the slide and the grip module would allow the striker to no longer be retained by the sear, and to move forward and discharge a round. In other words, the ongoing relative movement between the slide and the grip module while secured in a Sig Sauer authorized holster over time will allow the striker foot to become disconnected from the sear face. For reference, the contact surface area measured 0.038" (0.2 mm). No documentation has been provided by Sig Sauer that identified what the design specification is for the contact surface area between the striker foot and the sear.

Figure 9 - Subject striker foot to sear contact surface (left) and vertical offset (right)

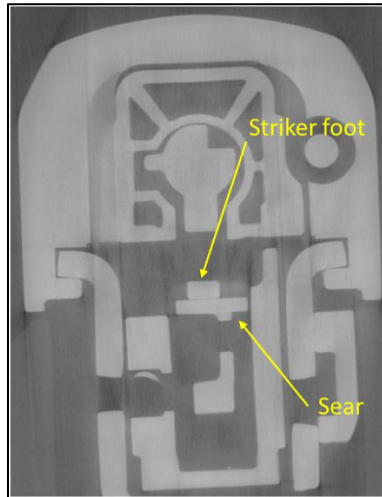
6. As shown in the CT scan below, there is also a lateral offset between the sear and the striker, causing an unbalanced force on the sear, and off-center contact on the sear. This off-center contact between the two components allows the sear to be loaded laterally, causing the striker foot to make more contact on one side versus the other. When the sear is consistently loaded in one direction due to the misalignment, it contributes to reducing the actual contact surface area between the striker foot and the step in the sear. The CT scan of this offset is shown in Figure 10. Figure 4 above shows the off-center and inconsistent contact area from the striker foot on the sear step.

Figure 10 – CT scan slice of striker foot offset to sear

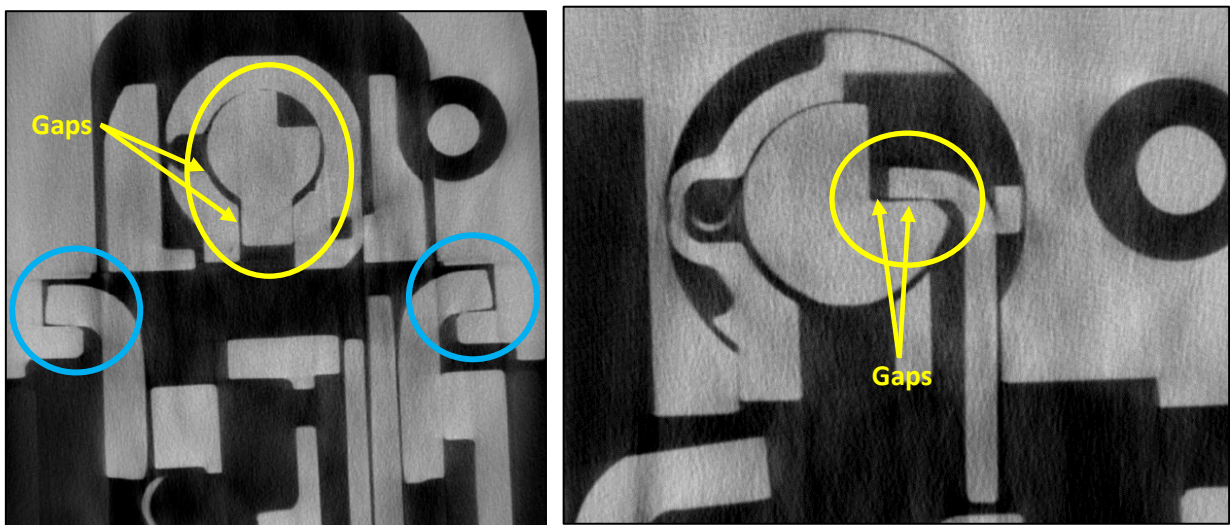
7. In looking at the rear-view CT scan slices of the striker pin relative to the housing, there are gaps within the striker housing, as shown in Figure 11 (left within yellow circle). This allows for axial rotation and movement of the striker pin within the housing each time the firearm is discharged and the slide cycles. This movement will also cause the safety lock tab that makes contact with the parallel horizontal plane of the striker body to become out of alignment, and not parallel, creating a gap. Based on the component drawings supplied by Sig Sauer, the maximum allowable angle of the striker pin to the housing is nearly 4° , however, Sig Sauer had not produced any assembly drawings that documents the specification of the complete striker assembly. The misalignment and rotation will cause minimal contact between the safety lock tab and the rear vertical stop portion of the striker, thereby reducing the contact area between the two surfaces. The misalignment would allow the striker pin to continue its forward movement when the striker foot is no longer retained by the sear, leading to an un-commanded discharge. The misalignment of the safety lock tab to the striker pin is also shown in Figure 11 (right).

Figure 11 - CT scan view from the front of striker gaps to housing (left) and safety lock tab misalignment to striker pin (right)

8. The CT images from Figure 11 (left) above also illustrate the slide assembly gaps to the grip module (circled in blue). These gaps allow the striker foot (as part of the slide assembly) to move vertically and laterally relative to the sear (in grip module) with any vertical and lateral movement, such as that experienced while the firearm is carried in a holster. The frame receiver stamping is not made to specification which contributes to the variation and fitment issues between the slide assembly and the grip module. The horizontal legs are both over 96° from the vertical leg, when the drawing specification indicates 90°. Also, the overall width between the slide tabs measured 21.6 mm, smaller than the 21.81 mm nominal specification. The CT scan is shown below (left) with the frame receiver stamping drawing image (right) in Figure 12. The bottom surface of the receiver tabs are shown as datum "Z" on the Sig Sauer drawing 1301552⁹ and all four tabs have a GD&T callout specifying flatness as 0.1 mm. Since none of the four tabs on the frame receiver stamping are perpendicular or flat relative to datum "Z", the frame receiver component does not meet the drawing specification.

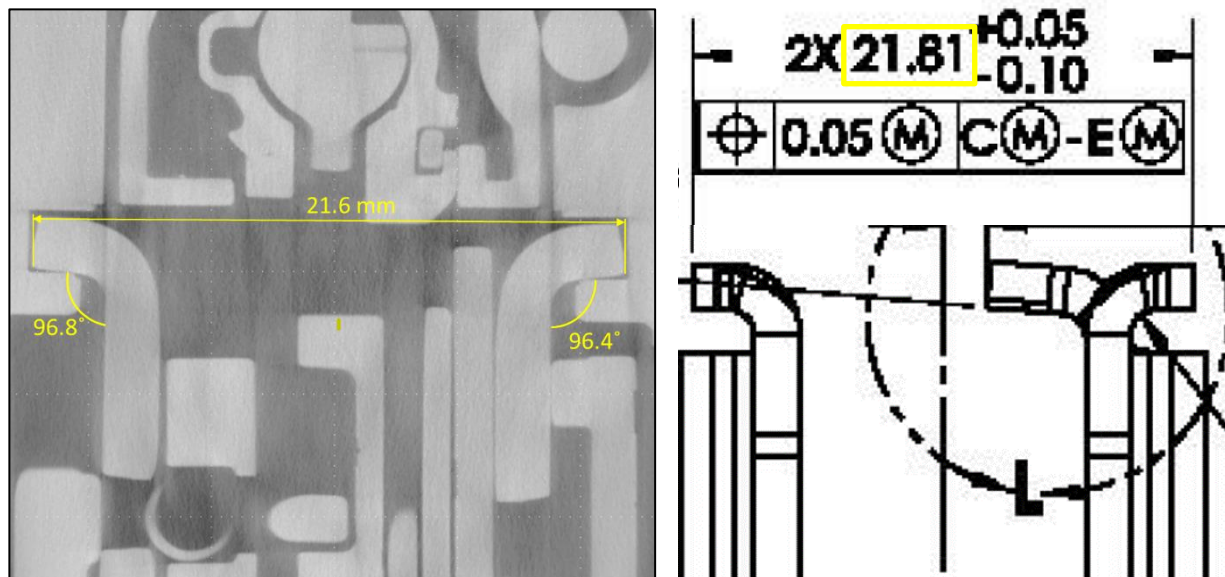
Additionally, the slots machined in the slide where the four frame receiver tabs are retained measured 0.089" (2.28 mm). However, as the slide slot dimensions or tolerances are not identified on any of the slide machining drawings produced, this measurement could not be verified. If these slots were also out of specification (too large), then this would also contribute to the amount of variation and play (sloppiness) between the slide assembly and the grip module. The frame receiver material thickness was measured at approximately 2 mm, with a minimum of 1.9 mm specified on the Sig Sauer drawing.

Figure 12 - Receiver stamping measurements from CT scan (left), Sig receiver drawing #1301552

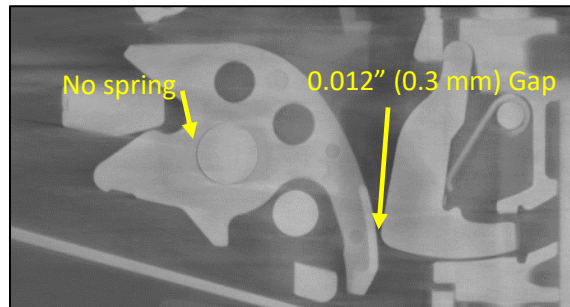
9. Detective Hilton's subject P320 X Carry also did not have the safety lever return spring installed which was used to fully retract the safety lever after the trigger is released. Sig Sauer discontinued the use of this return spring at some point after initiating the P320 upgrade program. The discontinued use of the return spring by Sig Sauer can also contribute to un-commanded discharge as the safety lever does not work as intended if the firearm is carried with the barrel down or upside down, since Sig Sauer designed the safety

lever to stay in position with gravity. Since the subject P320 was secured in a Sig Sauer authorized Blackhawk holster in her purse, there is nothing to keep the safety lever in position when the firearm is not kept with the barrel horizontal. Also, any amount of trigger mechanism movement from vibration or inertial forces can create the scenario where it would make contact with the safety lock and move it out of position, and therefore it would not restrain the striker movement leading to an un-commanded discharge. The CT scan showing the discontinued spring and minimal gap is shown in Figure 13 in a muzzle down orientation.

Figure 13 - CT scan of safety lever with no return spring and minimal gap to safety lock

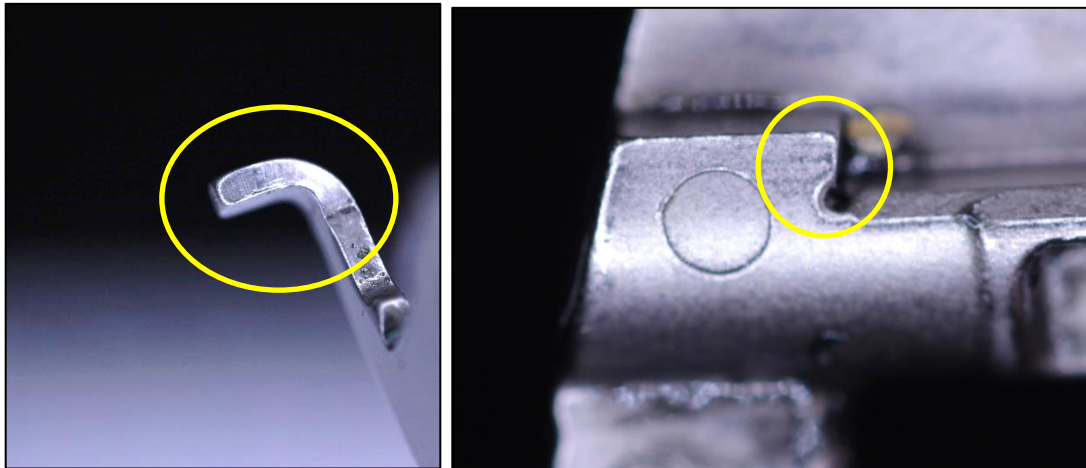
10. In addition to the issues related to the missing safety lever return spring discussed above, as well as the misalignment of these two components, there were also issues noted with the safety lock and the striker stop components. The tab portion of the safety lock had an inconsistent surface, due to being a stamped steel part and unfinished on the area that would engage the striker stop, shown in Figure 14 (left). Correspondingly, the striker stop surface was rounded and unfinished (MIM), as shown in Figure 14 (right). The combination of these two poorly manufactured surfaces would allow the striker to not be restrained by the safety lock, allowing an un-commanded discharge.

Figure 14 - Manufacturing issues with the safety lock tab (left) and the striker stop (right)

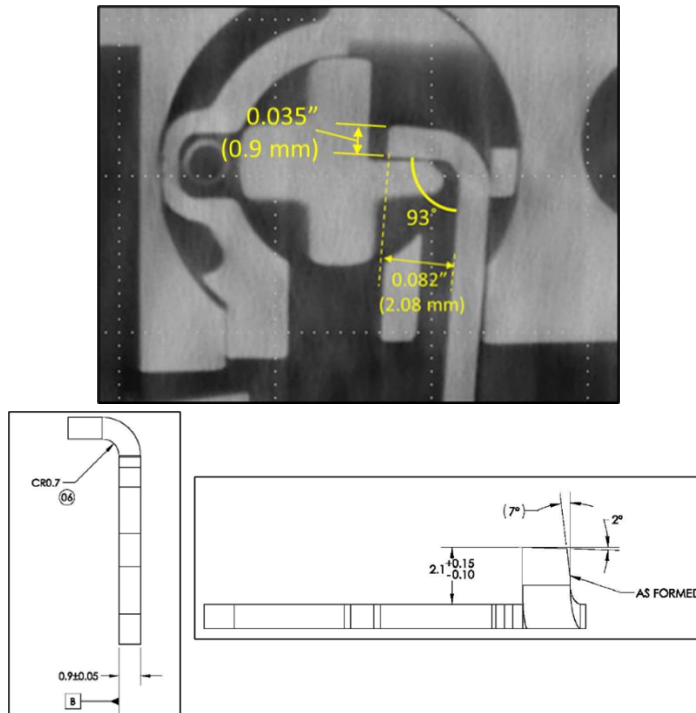
Additionally, the CT scan was utilized to quantify certain safety lock and striker stop measurements. Figure 15 shows the CT scan measurements for the safety lock (top) and the corresponding area from the Sig Sauer drawing #1301029¹⁰ (bottom), which show the safety lock tab is not formed properly at 93°, with

the drawing indicating 90°, and with a bend radius measured at 0.31" (.79 mm) compared to the drawing specification of 0.028" (.70 mm). The profile of the surface shown in Figure 15 (left) of the safety lock tab, that is intended to come into contact with the striker stop, has a tolerance specified as .008" (0.2 mm). The actual surface quality could not be measured with the CT scan, but it does not appear to visually meet the drawing specification.

Figure 15 - Safety lock image from CT scan (top), and images from Sig Sauer drawing of safety lock (bottom)

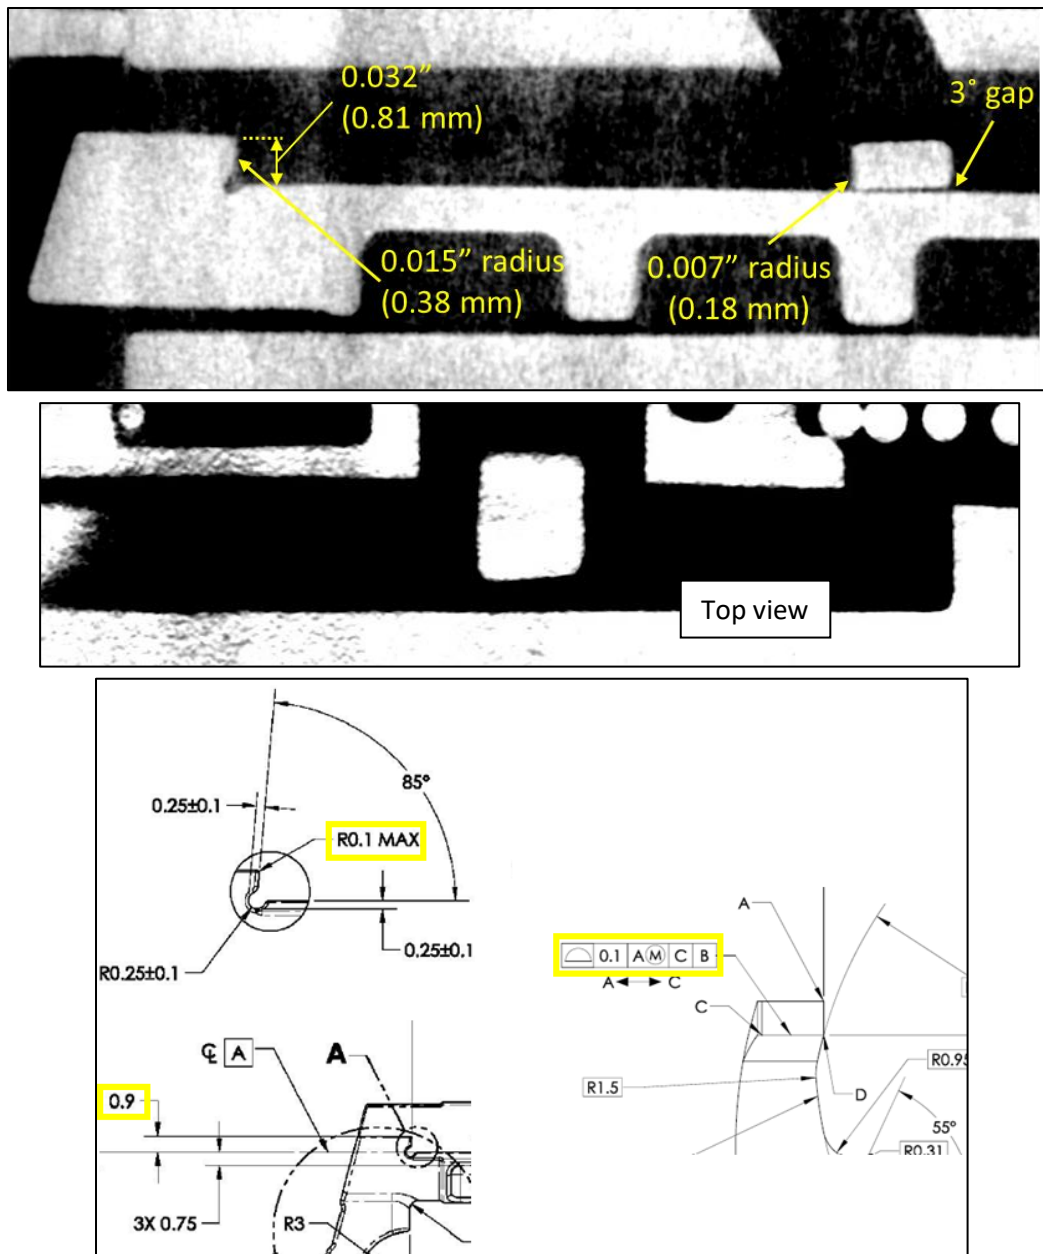
The CT scan was also used to measure and quantify the safety lock and striker stop from a side view. Figure 16 shows the CT scan measurements for the striker stop and safety lock (top and center) and the corresponding area from the Sig Sauer drawings (bottom). These images show the safety lock tab is not formed properly since the 3° gap (which measured at 0.005" or 0.127 mm) is beyond the surface profile designation on the Sig Sauer drawing¹¹ of 0.004" (0.1 mm). The striker stop has a 0.030" (0.38 mm) radius profile and is 0.032" (0.81 mm) high, compared to 0.004" (0.1 mm) and 0.035" (0.9 mm) respectively, from the Sig Sauer drawing #1302193¹², shown in Figure 16 (bottom).

Figure 16 - CT scan of striker stop and safety lock (top), top view of same parts (center), Sig Sauer drawings of the same parts (below)

Since the thickness of the safety lock is specified as 0.035" (0.9 mm), the combination of the quality issues discussed above, misalignment of the striker and safety lock, and possible contact from the safety lever, it means that less than 1 mm of displacement of the safety lock will not stop the striker from moving forward if the striker becomes displaced from the sear without a trigger pull.

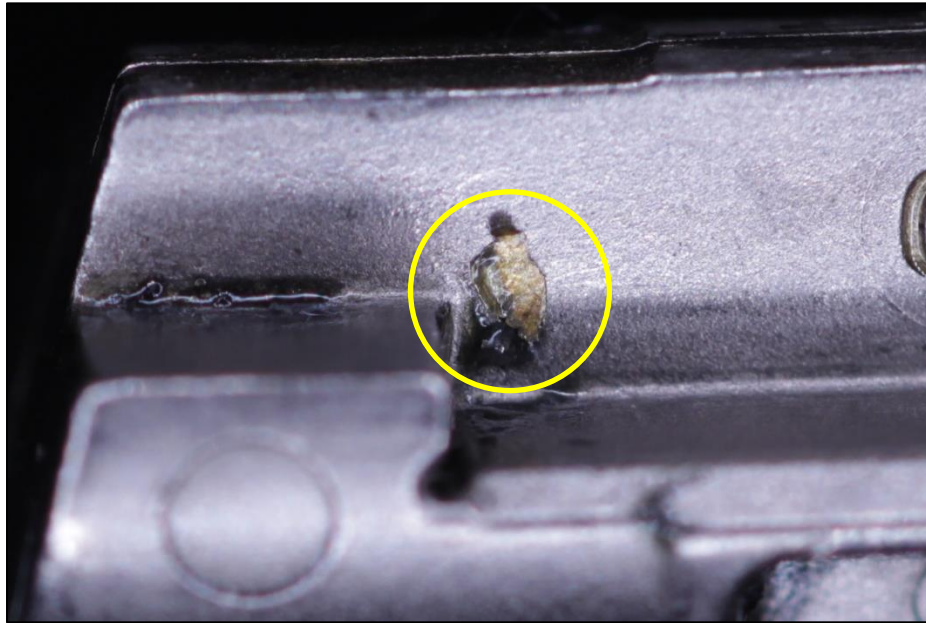
11. After the striker assembly had been disassembled, it was noticed that there was a piece of brass lodged in the corner of the striker vertical stop and the center wall area of the striker pin. In its as-found location, the safety lock tab would have made contact with it when the striker was released without a trigger pull. In this situation of having no trigger pull, the safety lock is supposed to come into contact with and stop the forward movement of the striker. Due to the components being out of specification, and the errant

brass found inside the striker assembly, the safety lock would be unable to perform its function. See Figure 17.

Figure 17 - Striker pin with brass debris at vertical stop

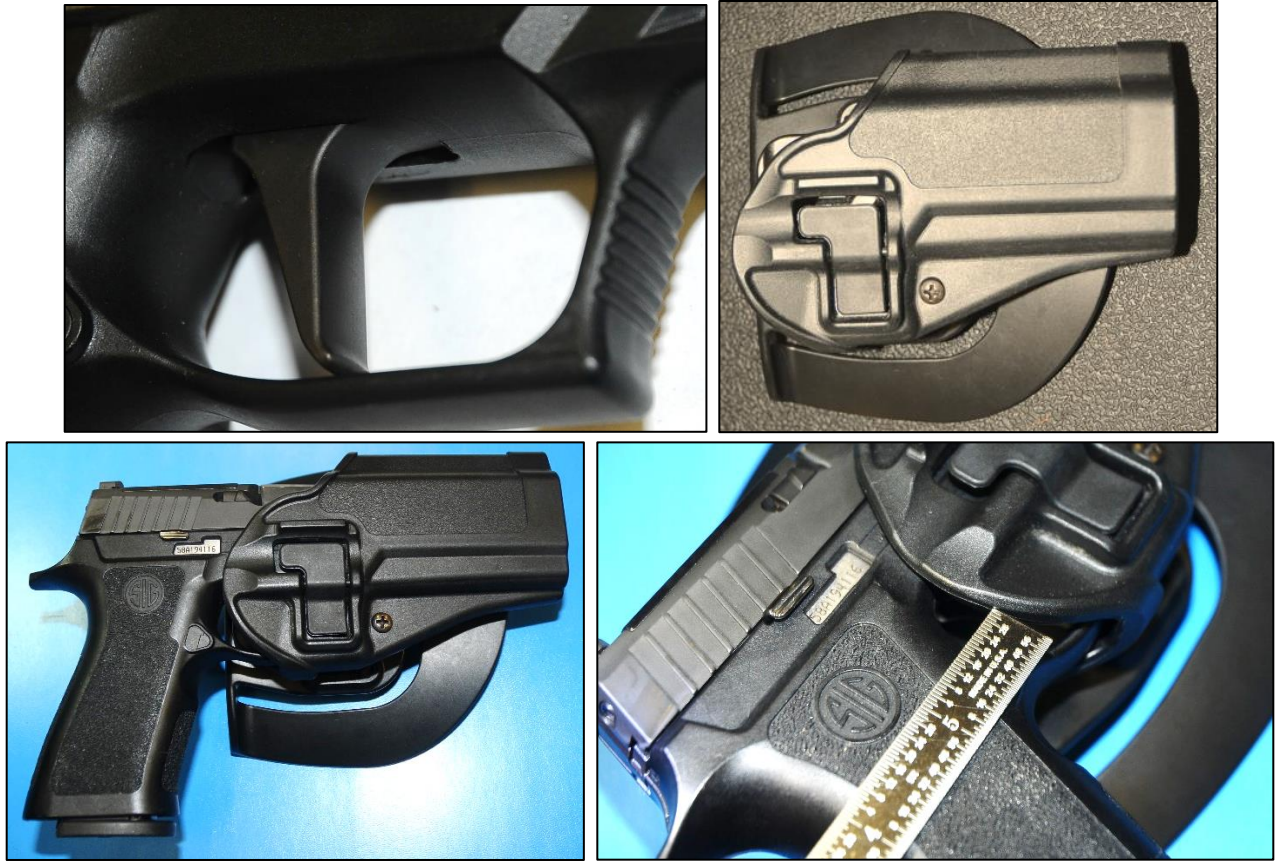
12. No unusual wear or significant damage was identified on either the subject firearm or the Blackhawk holster. Normal wear was observed on both. In particular, the trigger appeared to be in good condition with no finish damage or gouges visible. See Figure 18. The damage identified in the Sig Sauer inspection report could not be confirmed. The firearm fit snugly and secure inside the holster and the trigger was well protected. The holster has a locking engagement with the trigger guard, with a lever needing to be depressed by the index finger in order to release the firearm.

Figure 18 - Subject trigger and Blackhawk holster

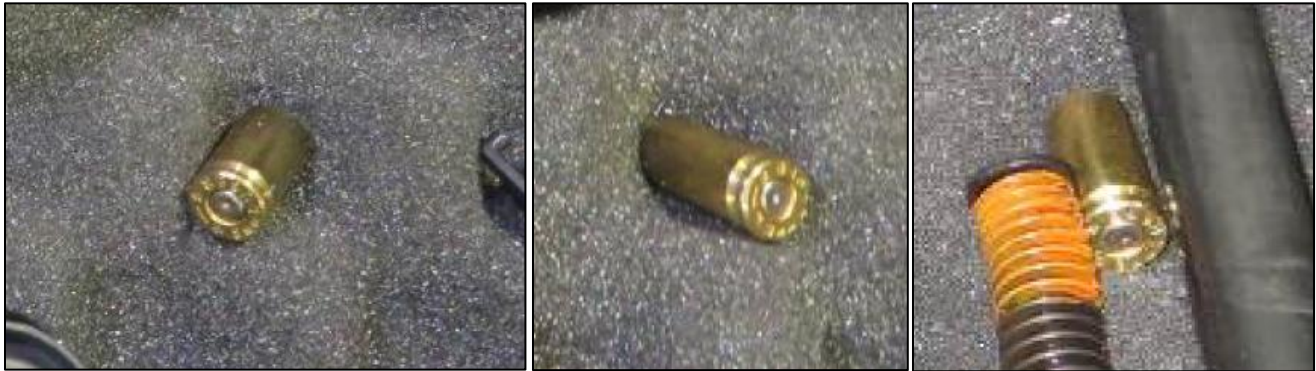
referred to as “light strikes” in this report, but it is possible the primer was ignited and not noted in the summary report. Examples of photographs showing the “light strikes” are shown in Figure 19.

Figure 19 – Sig Sauer Vibration Test #1 photo #29 (left), photo #30 (center), photo #65 (right) – All with primer light strike marks

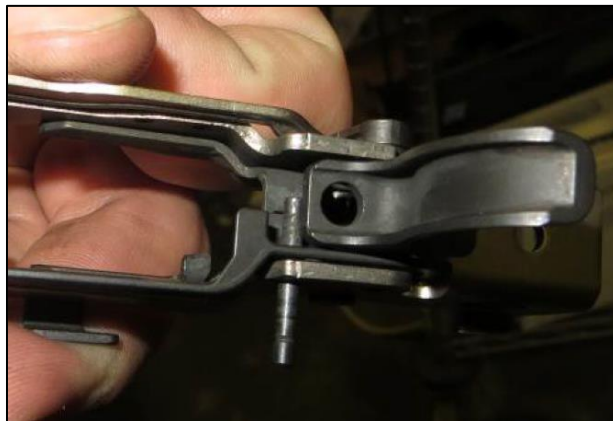
Additionally, the vibration test #1, iteration #3 had a trigger stop pin become displaced, as shown in Figure 20.

Figure 20 - Vibration Test #1 Iteration #3 Photo #66 showing trigger stop pin displaced
